Manhole Inspection Summary

Manhole # S25A__041MH

Insp Date: **8/21/07 11:29 AM**

Location Address: **1205 HARLEM ST**

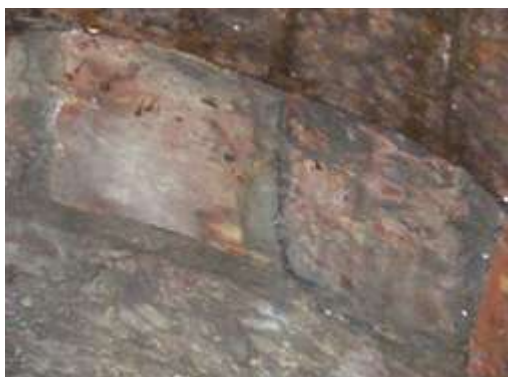
Defect 3

Chimney / Frame Adjustment ☒ Exists Material: **Brick** ☐ Parged Height: **6** (in.)

Condition: ☐ Sound ☒ **Cracked** ☐ Root Intrusion ☐ Loose Brick ☐ Deteriorated

CRACKED CHIMNEY

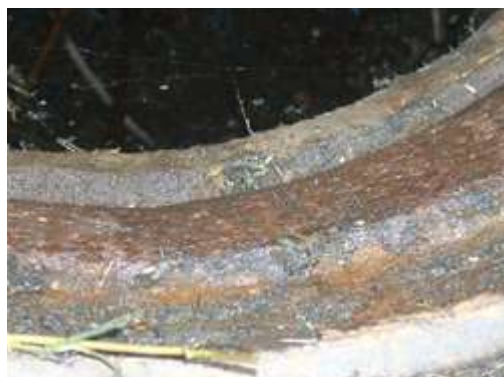
Defect 2

Frame Offset: **1** (in.) Condition: ☒ Sound ☐ Cracked ☐ Leaks

FRAME OFFSET

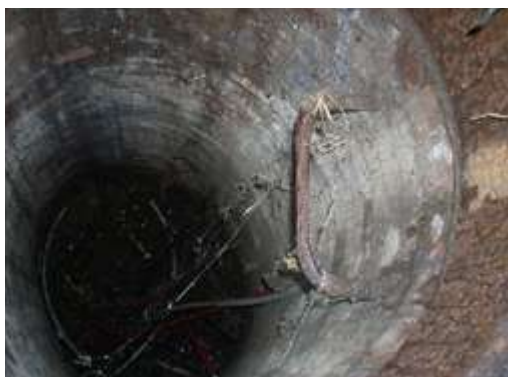
Defect 1

Steps Count: **5** Missing: **1** ☒ **Corroded**

MISSING AND CORRODED STEPS

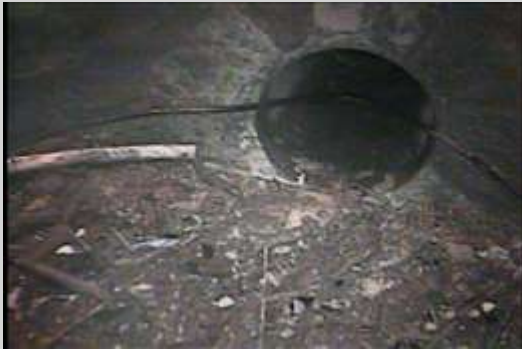
12 O'Clock Outflow

8 in. Circular Gravity Sewer
Pipe Out @ 12 O'Clock

Infiltration: **None** Pipe Seal Cond: **Sound**
